NEWTOWN, CONNECTICUT

# HATTERTOWN POND DAM CT 00313

## PHASE I INSPECTION REPORT NATIONAL DAM INSPECTION PROGRAM

MAY 1981

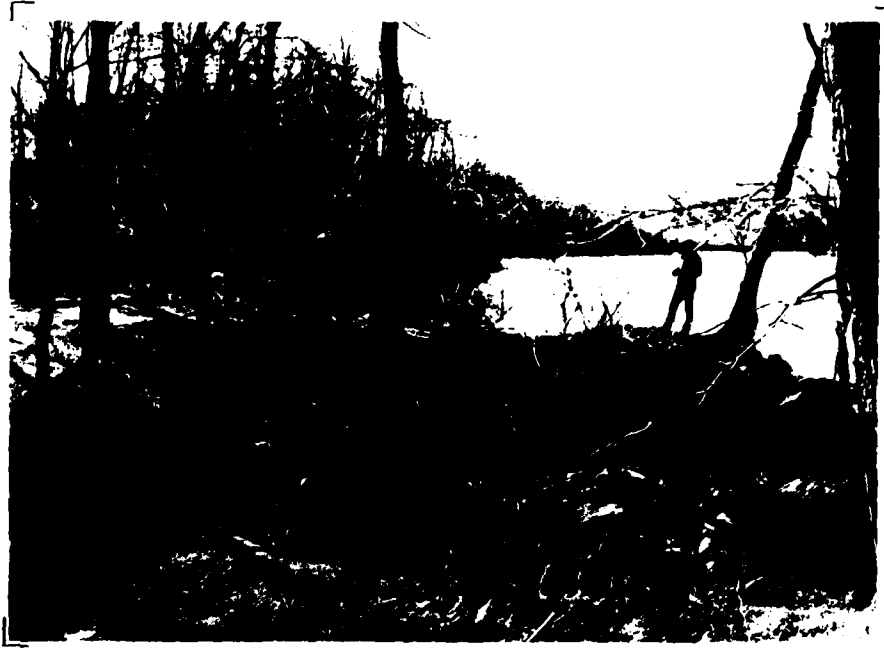
The downstream slope and spillway discharge channel are strewn with debris from previous failures of the existing dam and the remains of another breached dam located 40 feet downstream. The Hattertown Pond Dam is located in a wooded area; consequently, the downstream channel has also been overgrown with trees and brush (Photo 5). The upstream slope was, for the most part, beneath the water surface, however those portions of the slope that were exposed lacked riprap protection and appeared irregular due to erosion near the exposed tree roots.

Photo 3 Top and downstream slope of embankment and  
breached earth dam in foreground.

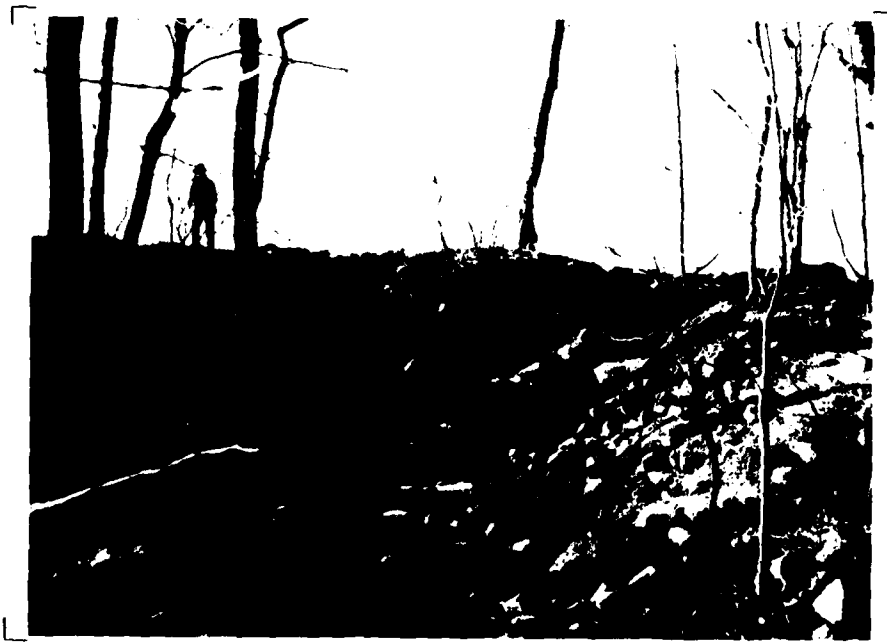
Photo 4 Downstream slope of existing dam, outlet channel,  
and remains of breached earth dam.

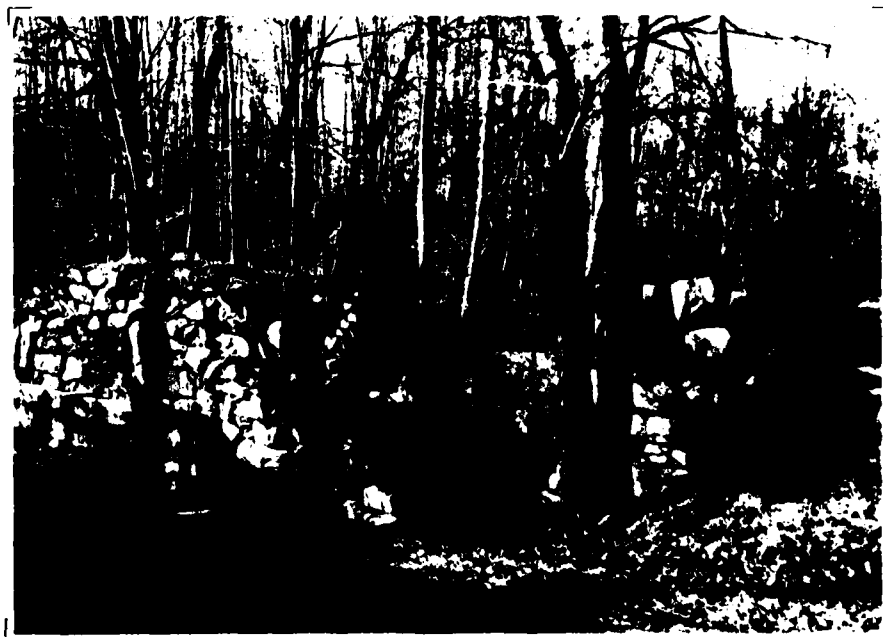
NOTE:  
 PHOTO 6 WAS TAKEN WHERE LEWIS BROOK  
 FLOWS UNDER CASTLE MEADOW ROAD (SEE  
 DRAINAGE AREA MAP IN APPENDIX D FOR  
 THE ROAD LOCATION).

Photo 6 Breached dam near Castle Meadow Road bridge culvert.
